MEMORANDUM

Subject: Lake Tishomingo Site Visit and Slope Monitoring

Date: June 11, 2019

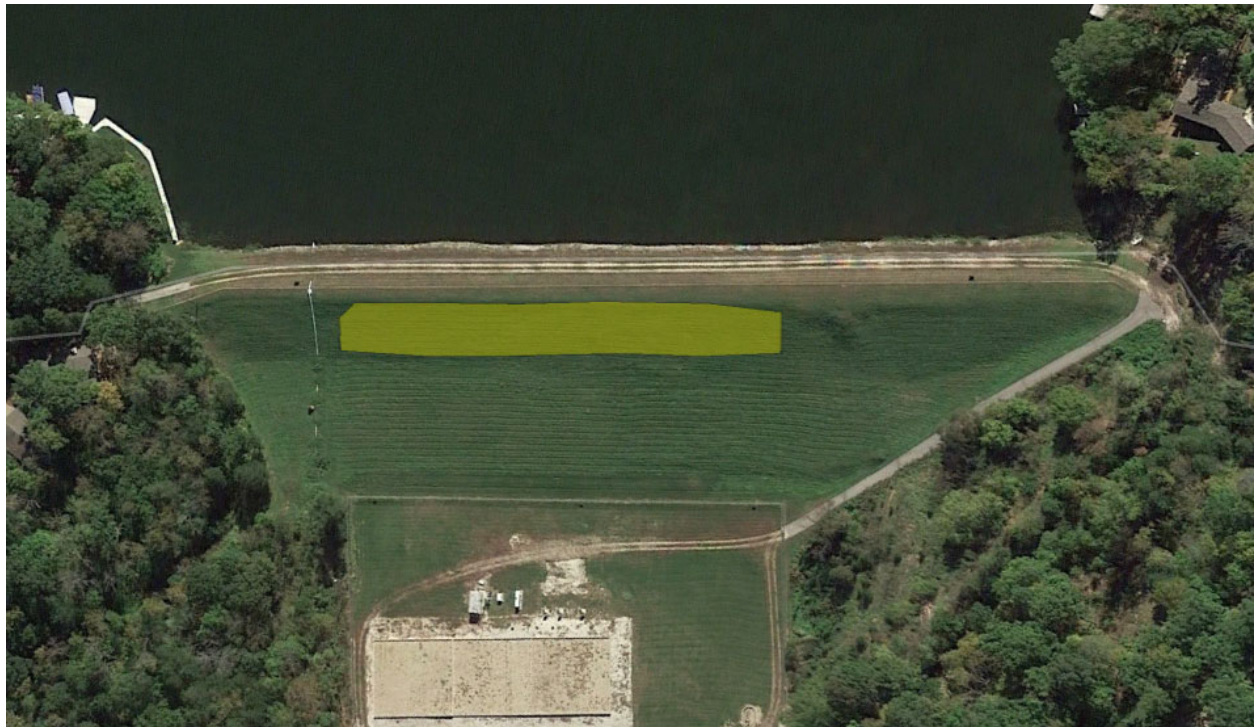
At your request Stacy Bonderer and I made a site visit on June 7, 2019, to observe a reported bulge in the downstream slope of the Lake Tishomingo Dam. Your mowing company noticed the change and placed flags outlining the area they believe had bulged or moved and become steeper. The flags were placed on the steeper and upper dam fill section. The flags were placed in an upper and lower line that ran from approximately the siphon and to an old slide. The upper line was a few feet downslope from the downstream shoulder, and the lower line was near the downstream slope break. The approximate area inside the flags is shaded in yellow in the aerial below.

We walked the area and did not observe signs of seepage, cracking or a defined head or toe scarp. The downstream slope was built with a somewhat uneven surface, but it appears possible that some movement may have occurred in this upper section at some point in time. We flagged two areas during our visit that are most noticeable as potential locations for head or toe scarps.

It was not possible to definitively say whether movement has occurred by visual observation only. If slope movement was occurring in the areas defined by the flagging it appears to be a relatively shallow slide mass confined to the upper steeper portion of the dam. Due to its position high on the dam and without any observed seepage, it appears that this type of failure would be driven by recent rainfall saturating the soil on the downstream slope.

Reitz & Jens used existing historical data to model the slope to see how critical this potential and assumed slope failure is to the overall stability of the dam. Based on this analysis it does not appear that further movement would immediately cause catastrophic failure; however, if a slide is identified then corrective measures should be implemented as soon as possible.

We recommend visually monitoring the downstream slope routinely and after rain events to see if additional movement is occurring. The two areas flagged during our site visit should receive particular attention. If signs of movement, cracking or seepage are observed then you should notify us immediately for further action.

Inclinometers are the preferred alternative. These are a vertical PVC casing that is used in conjunction with a probe to monitor soil movement with depth. We would recommend 2 to 4 inclinometers spaced evenly and near the center of the shaded area. We estimate the cost to install 3 inclinometers as approximately \$13,500. This cost includes time to cut benches into the downstream slope for inclinometer installation and to regrade and seed the slope after installation. An additional cost of approximately \$850 per trip would be required for monitoring.
