REITZ & JENS, INC.
CONSULTING ENGINEERS

Re: July 6, 2007 Site Visit

LAKE TISHIMINGO
SPILLWAY DETAILS

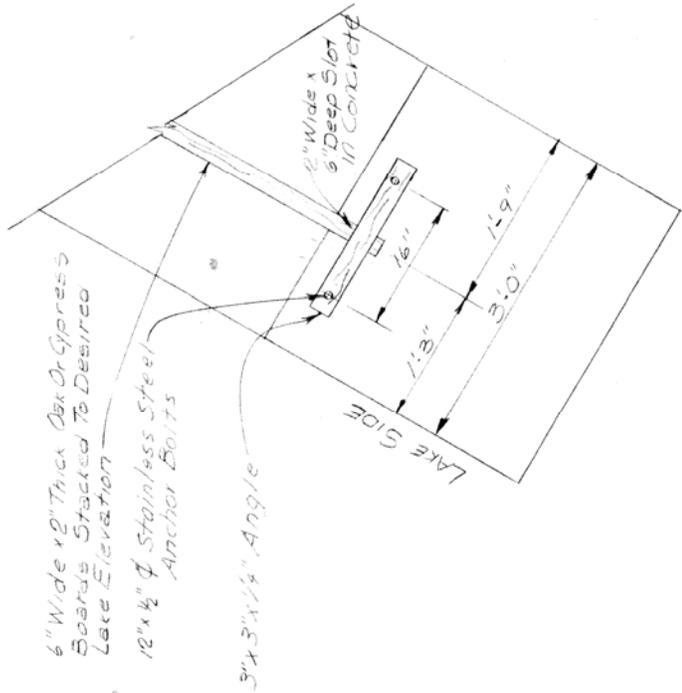
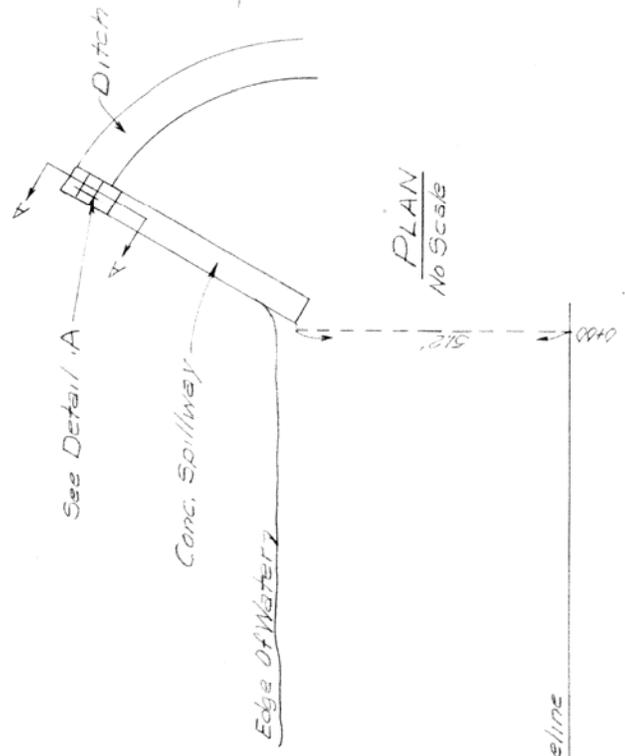
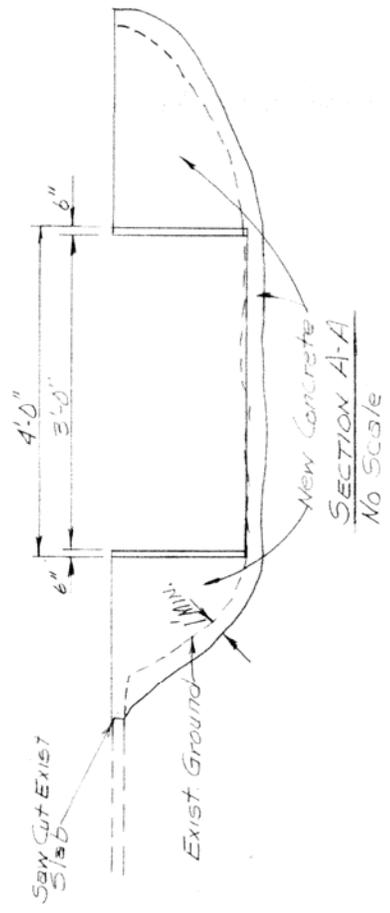
DETAIL A
No Scale

You have asked how to locate the old grout pipes. The pipe on the top of the dam shown

in the repair plans near baseline station 5+40 is thought to be one of the original grouting pipes. This pipe should be able to be located relative to the baseline if the two reference points on the baseline can be located. The attached sketch shows the only known tie to the pin at station 0+00. The baseline was set along the downstream crest line. The other pin location at station 8+36 is about 24 feet from a utility pole. If that pole is still there, a little digging and a metal detector should be able to find both of the baseline reference points. Once the baseline is established, the grout pipe should be easy to locate. Our notes indicate that Metropolitan Engineering did the field surveying for the plan preparation. They may have better notes for re-establishing the base line.
