Don Eskridge Interview

September 26, 2006

CH = Clarue Holland (Lake Tishomingo Dam Leak Cmte)

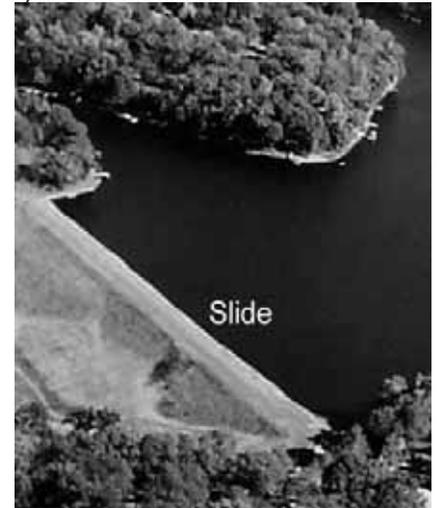
DE: In 1982 the MO DNR made the Lake repair a slide that occurred on the back of the dam (see Figure 1). But before the slide was repaired, the lake was lowered to reduce pressure on the dam. (There was water running out of the slide area.) The lake was lowered 4.5 to 5 feet by cutting a notch out of the spillway. This notch had to be quite long (100 ft or so) to lower the lake to the desired level, as the spillway has a relatively gentle slope. The notch was later repaired by filling in the notch with a mixture of clay and rock. DE did not know if the "plug" of clay and rock had ever been permanently repaired.

DE: The slide was believed to have occurred because of excessive moisture and because the back of the dam was too steep. Although the dam was built as designed (a 3:1 slope in the front and a 2:1 slope in the back), the back slope was judged to be too steep. So as part of the repair of the slide, the dam was flattened in the area of the slide **and** for the entire length of the dam. This occurred in 1986 - 1987. Also at this time, the top of the dam was raised by building a concrete wall the length of the dam. Only the drawings of this work remain, the correspondence files have been discarded.

Figure 1. Slide on back of dam

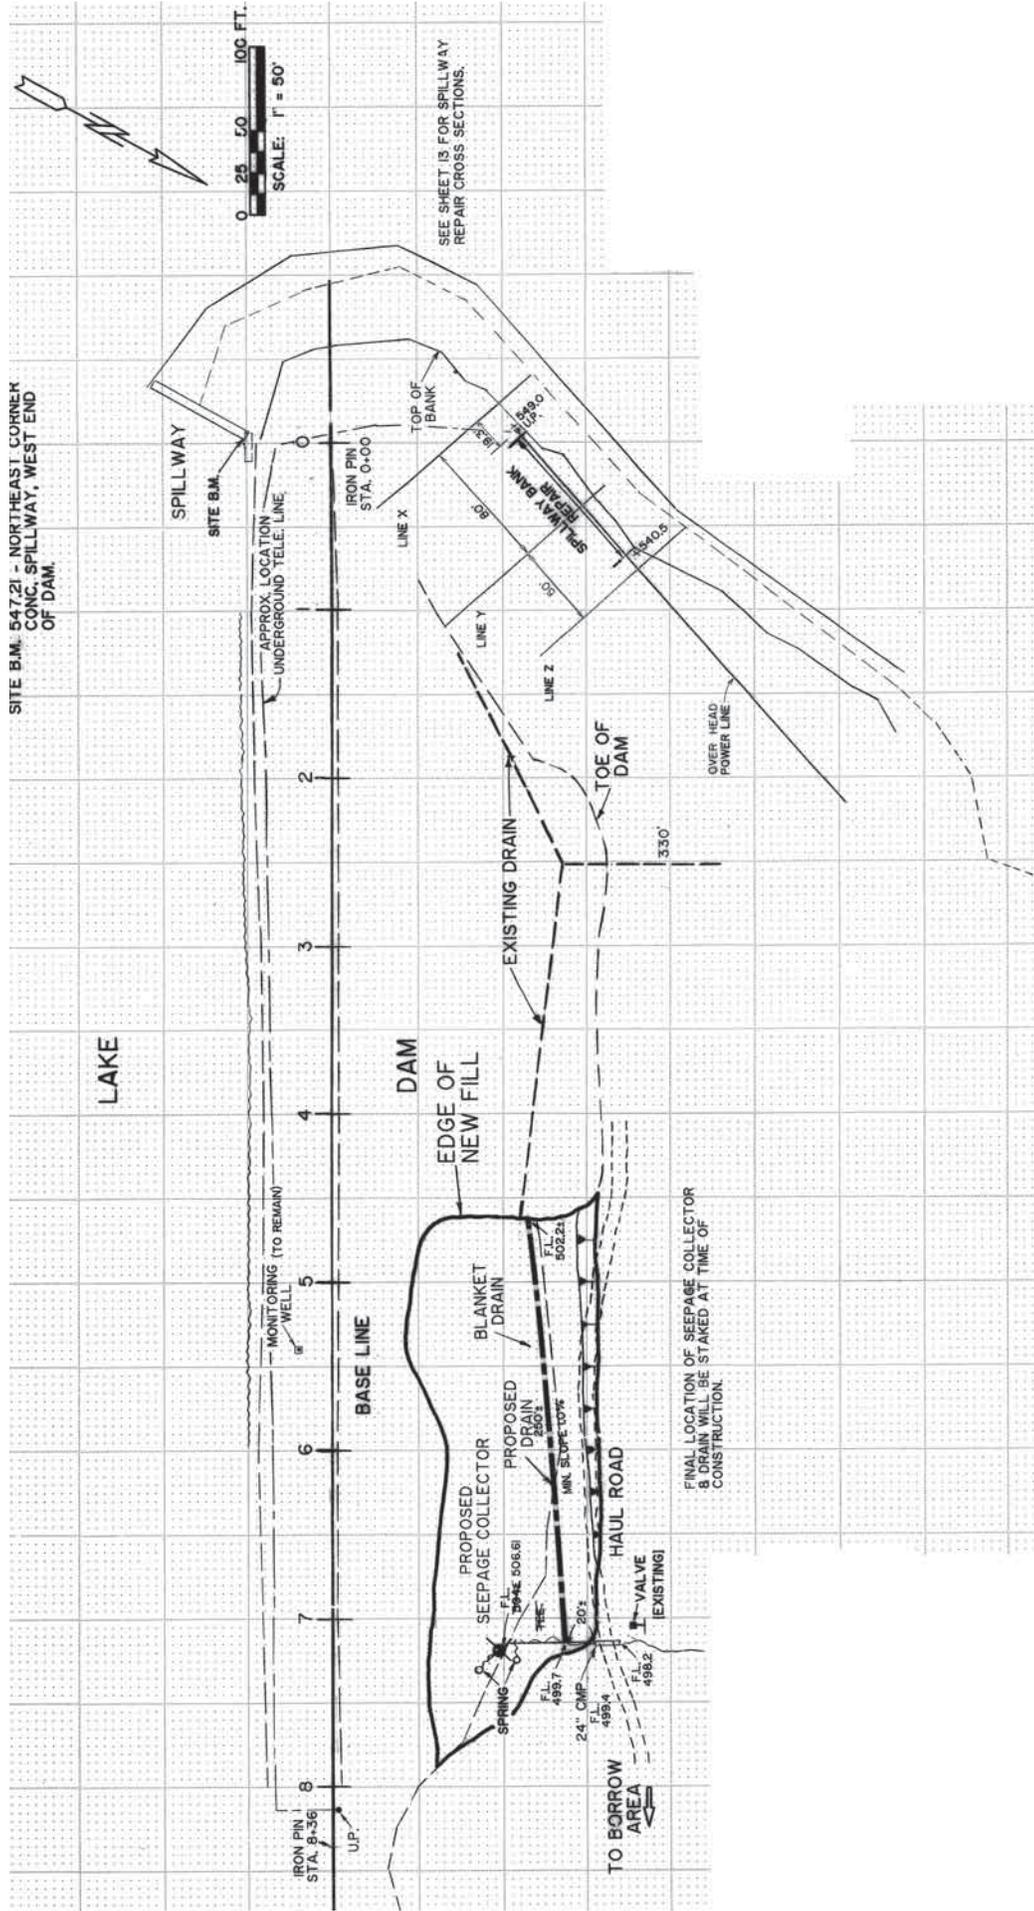
DE: During the first repair (ca. 1982) a drain was installed in the slide area on the south side of the dam that emptied into a gully some distance away from the toe of the dam. This drain is shown in Figure 2 labeled as "Existing Drain". Two sections of perforated pipe were installed in a sand trench at the toe of the dam. Nonperforated pipe (330 feet of 4 or 6 inch diameter PVC pipe) was "teed" in to empty several hundred feet away from the toe of the dam into a gully. (This pipe is **not** connected to the seepage collector that was installed in 1988.)

Figure 2. Various Features on Back of Dam

was installed to directly intercept seepage water flowing out of two springs located on the back of the dam (each spring is labeled as "Spring" in Figure 2). In addition to the seepage collector, 250 feet of perforated pipe was laid in a sand trench to collect additional seepage (labeled "proposed drain" in Figure 2). Both the seepage collector and the perforated pipe empty into the same pool that then flows under the "haul" road into a creek that connects to the spillway.

DE: In 1982 I talked to original lake developer. This guy was in his 80s at the time. He told me that there was a problem with leaks almost immediately after the dam was completed. The old guy said they sent divers down and they were able to detect a flow in "I" cove (the cove adjacent to the dam on the north side). On the back of the dam they found a large spring where a valve/pipe assembly is now located (labeled "Valve Existing" in Figure 2).

CH pointed out that there was an area near the back of the property behind the dam that we visited in July 2006 that did appear to have water coming out of the ground and that this water could be due to a plugged drain pipe. (RH: **We need to try to find this drain pipe and check its condition. DE warned against trying to find this drain pipe with a backhoe as that could seriously damage the pipe.**)

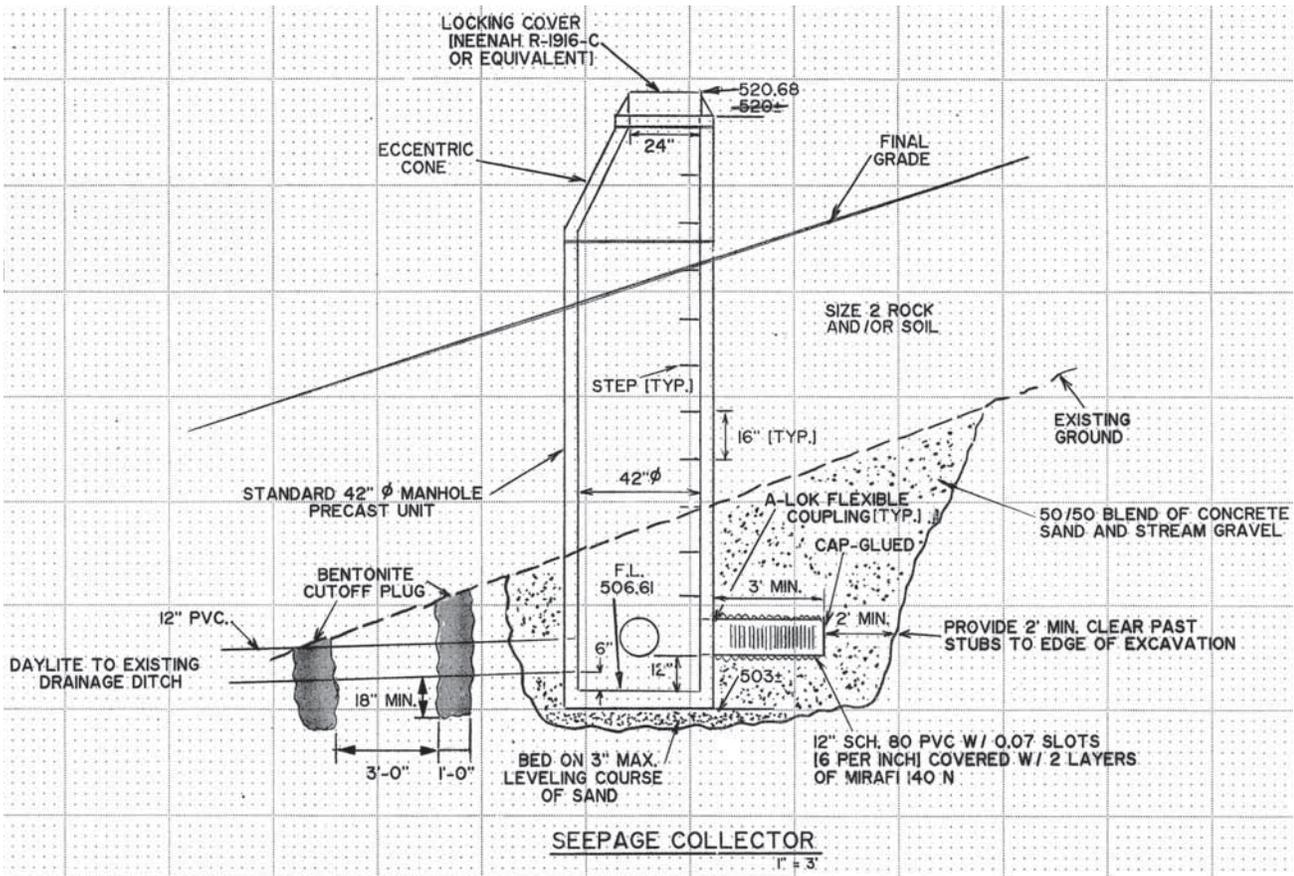
DE: "Phase two" of the work carried out in 1988 was just a continuation of the work begun in 1982, which was to increase the stability of the dam. Part of the work was to install the seepage collector. (See Figures 2 thru 5.) The seepage collector

Figure 3. Seepage Collector

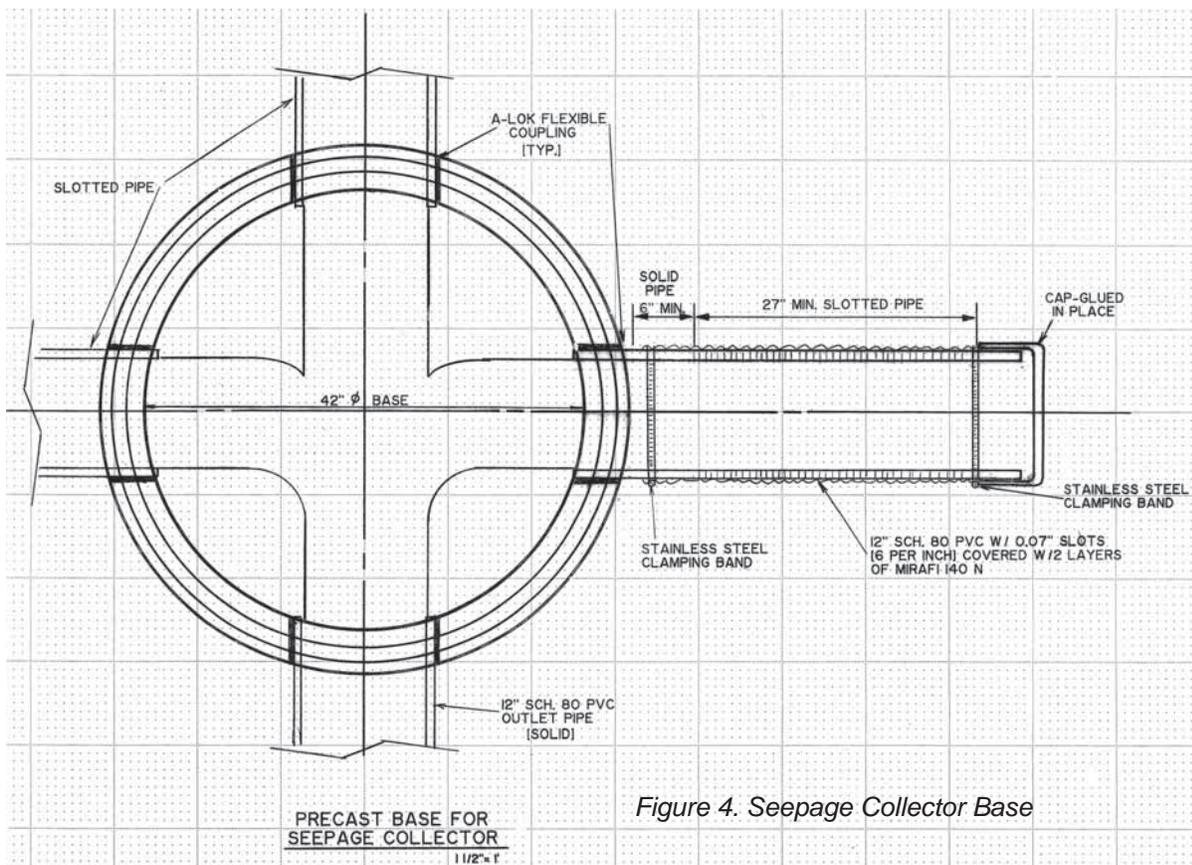
Figure 4. Seepage Collector Base

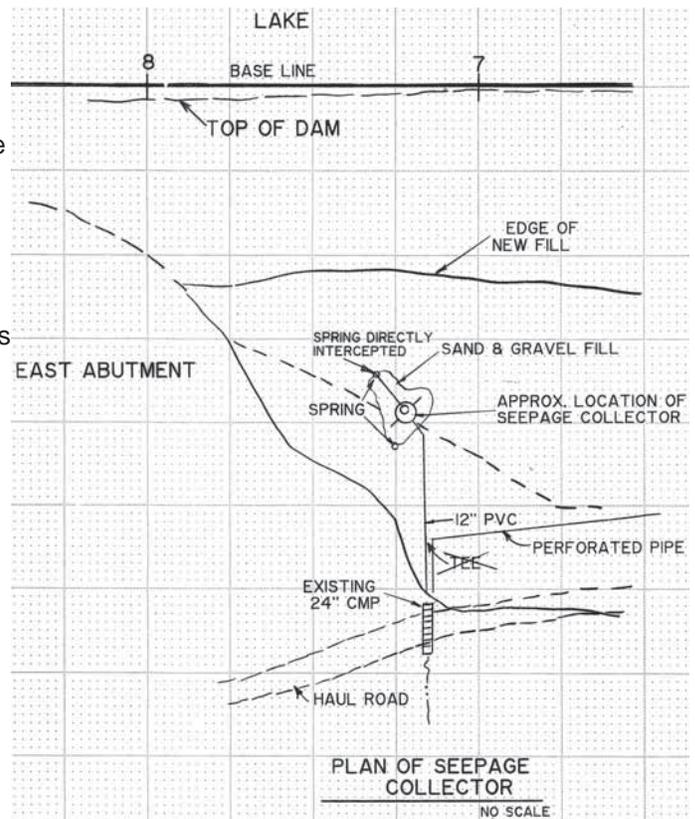
Figure 5. Seepage Collector Location

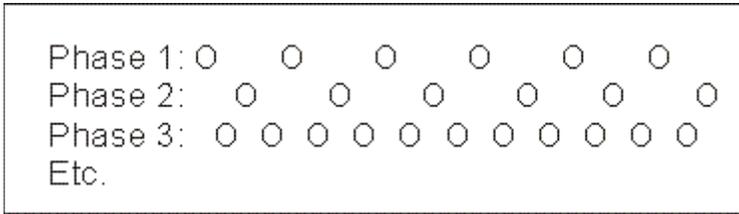
Figure 6. Grouting Sequence

DE: At Lake Chesterfield DT used the grouting approach and missed a few spots (probably thru no fault of his). He is now about to start a second round of grouting. DE drew an illustration similar to that shown in Figure 6 to illustrate the grouting sequence. In each phase grout is introduced thru pipes placed in holes drilled thru the top of the dam. In phase one the

pipes are placed some distance away from each other. In subsequent grouting phases, pipes are placed so grout fills voids missed in the previous grouting phase. Grouting stops when the leak is sufficiently slowed or the money runs out.

DE: To grout at Lake Tishomingo the contractor would probably use a plastic grout like a urethane foam. This would solve the problem of grouting with cement into a flowing stream of water.
