Lake Tishomingo Dam Repair

by Rich Hirsch, Dam Committee

Successful Repair of the Dam, June 2008

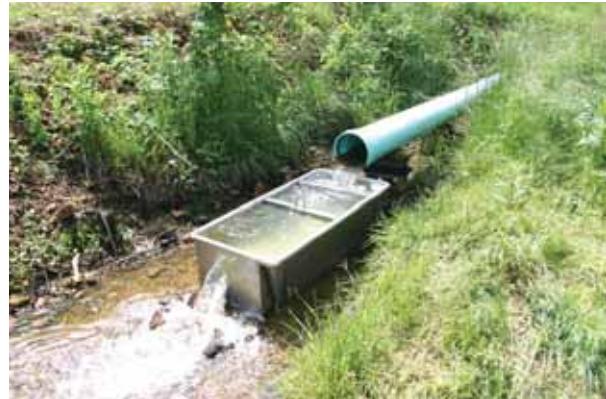
Weir box, constructed by Mike Leiweke, capturing leak flow at 300 gpm, before repair

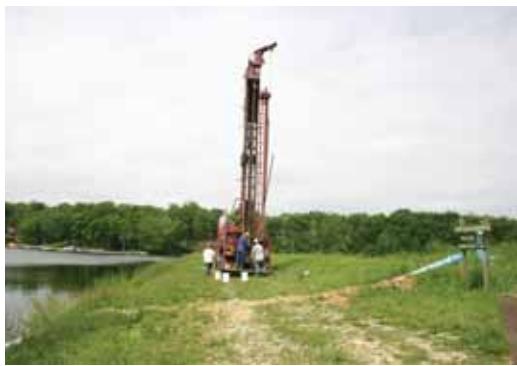
Drilling exploratory holes.

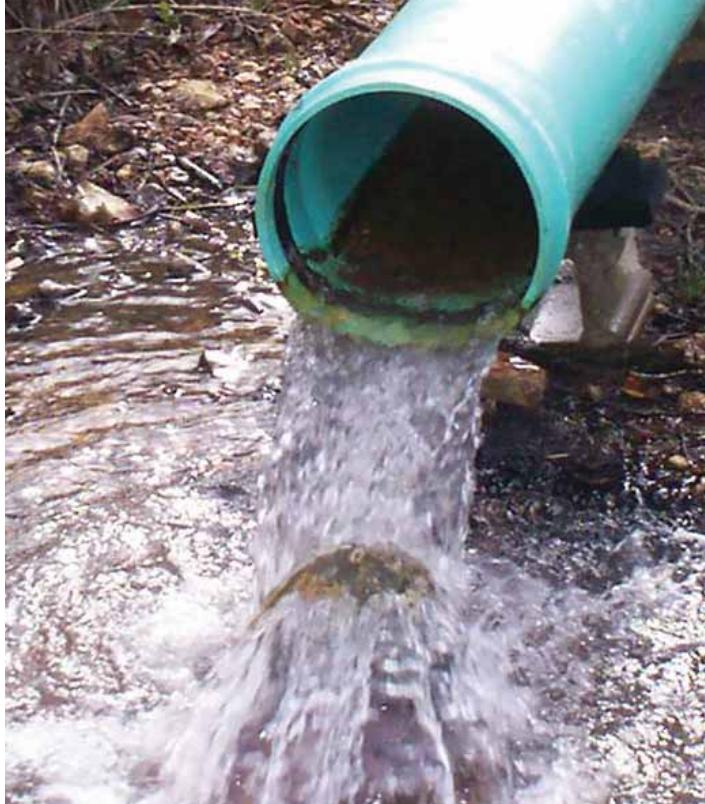
Water flow from leak collector, 300 gal/min, January 2008.

The output from the leak pipe dropped from 300 gpm to less than 1 gpm in less than 30 minutes. (see photo on p. 1. Left image is normal leak flow in Jan. 2008; right image is after grouting was complete. The difference is incredible.)

Although there were three drill holes (3, 4, & 5) that penetrated the fracture that caused the leak, only hole #4 was grouted. Four concrete truck loads of grout (with coarse sand added) were pumped down drill hole #4. Holes 3 & 5 were checked and grout was present in those pipes also, above the level of the fissure.

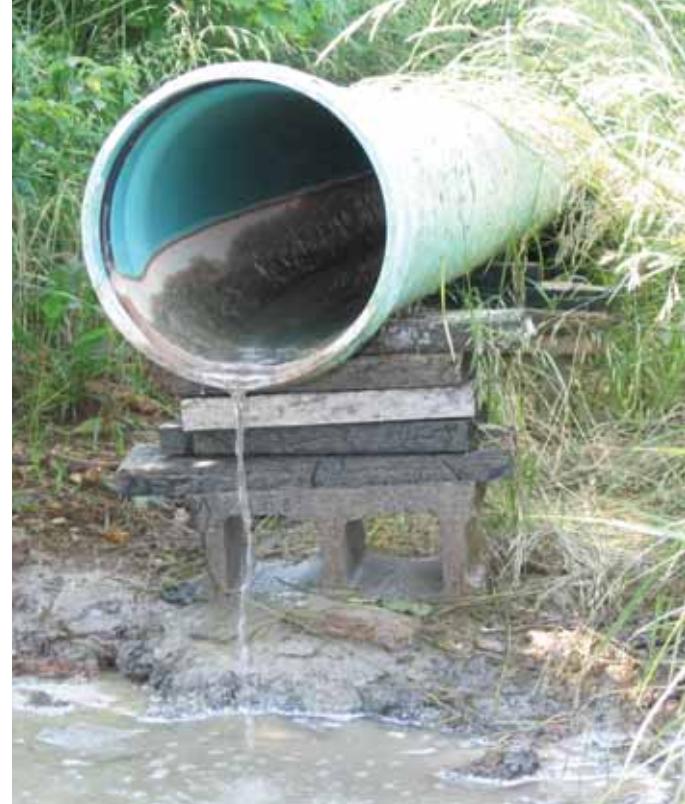
Water flow from leak collector, 0.6 gal/min, June 2008.

While DT was grouting the pipes, I visited the leak pipe to make sure the leak flow was still just a trickle. It was. I measured the flow rate at 0.6 gpm. This reduction, from approximately 300 gpm to 0.6 gpm is a rate reduction of 99.8%.
