## Dam Leak Committee Meeting Summary, November

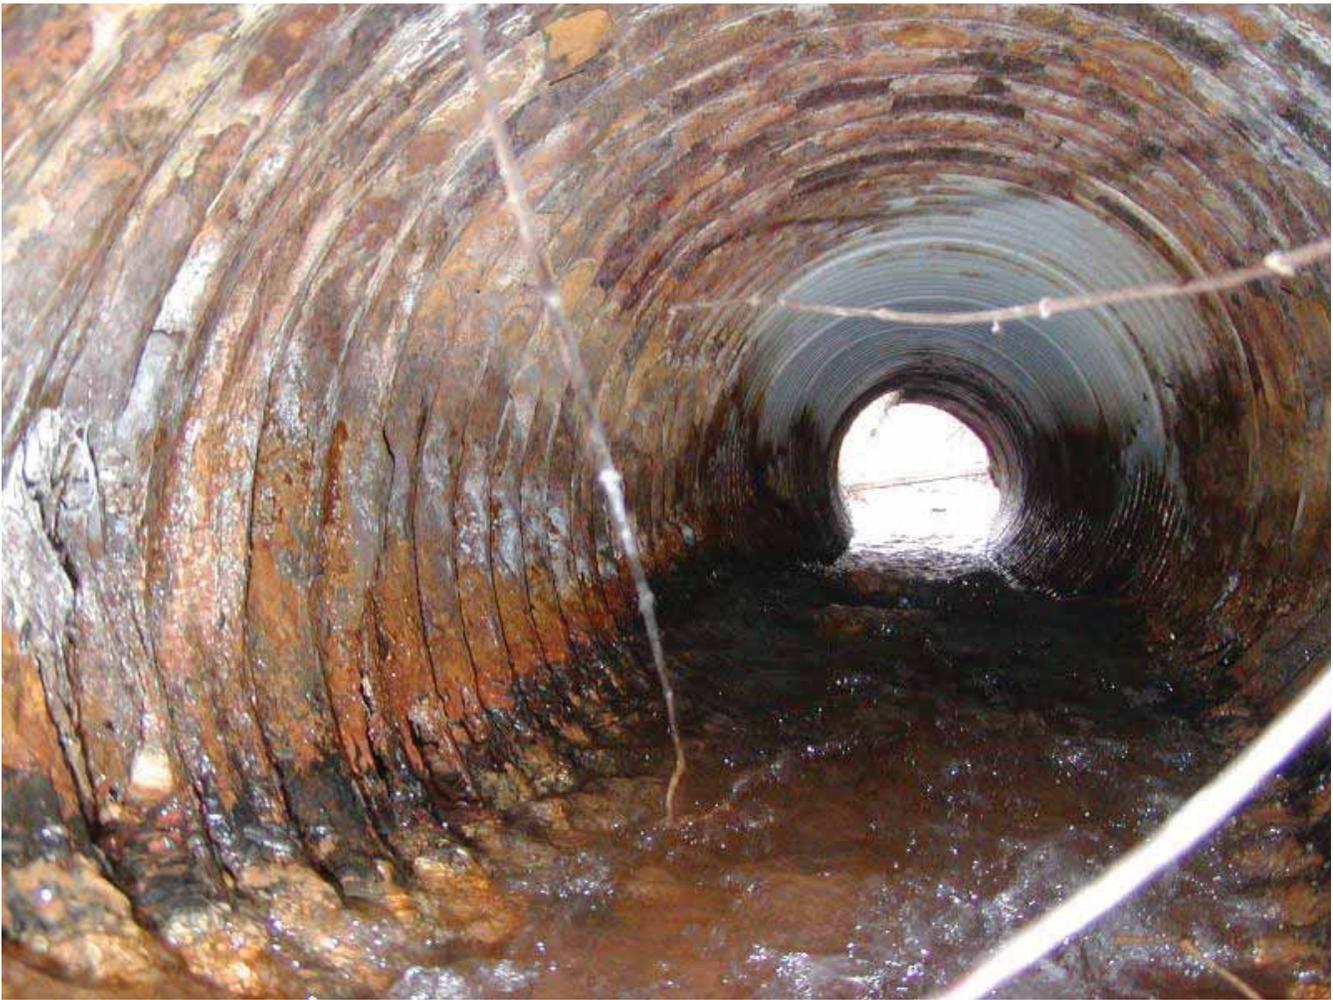
- 1) The 24" drainage pipe is badly corroded and should probably be replaced before the weir box is installed.
- 2) It is not a "straight shot" thru the 24" drainage pipe to connect a 12 inch extension pipe to the leak outlet pipe. It should, however, not be difficult to install a replacement 24" drainage pipe so that the smaller pipe fits easily within the outer pipe.

Above: View thru 24" x 20' drainage pipe, from leak pool.

- 1) Cost to replace the existing 24" x 20' drainage pipe with a plastic schedule 80 pipe and install two sections of 12" x 20' pipe with one plastic coupling and one flex coupling. Kevin Seelbach is best able to provide this info as he has the contacts and will provide the labor.
- 2) Cost to build the weir box. In terms of constructing the weir, although it would be possible for ML to construct a weir box out of stainless steel, the group felt it might be better to purchase a fiberglass box and for Mike to modify the box to hold the weir plate.

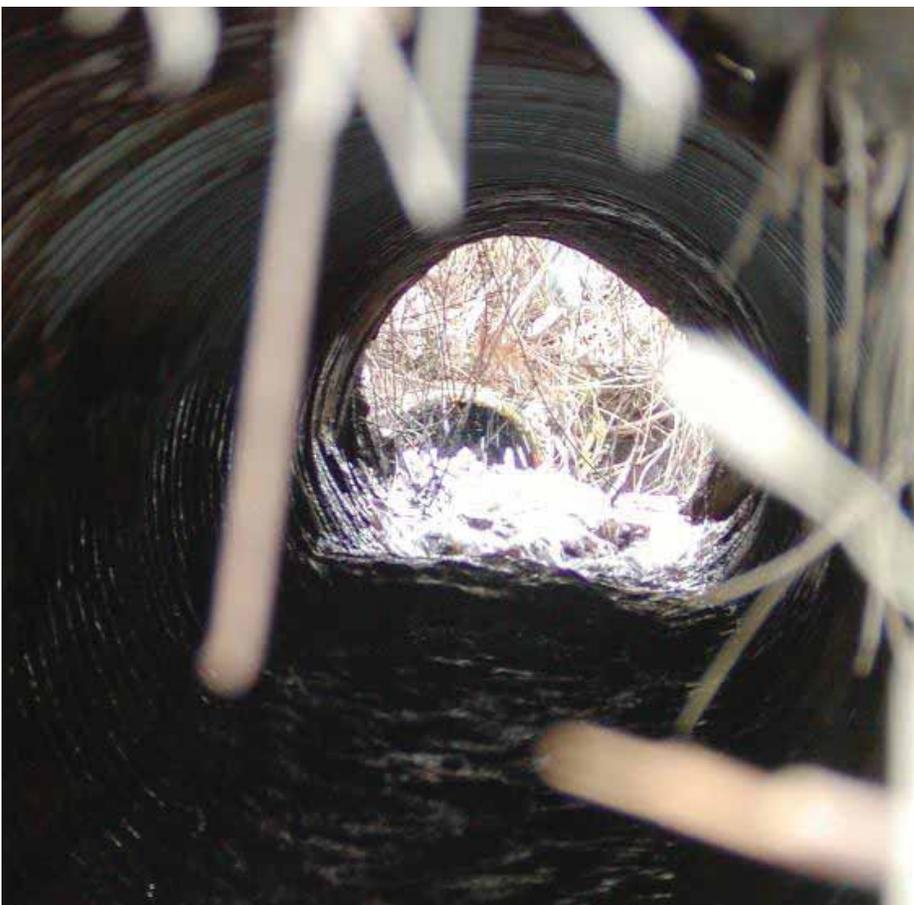
Left: View thru 24" drainage pipe, toward the leak pool. Leak outlet pipe is at center of photo.
