August 22 Dam Leak Committee Meeting Summary

Appendix A. Preliminary History Report by Clarue Holland, Lake Tishomingo Dam Committee, 17 August 2006

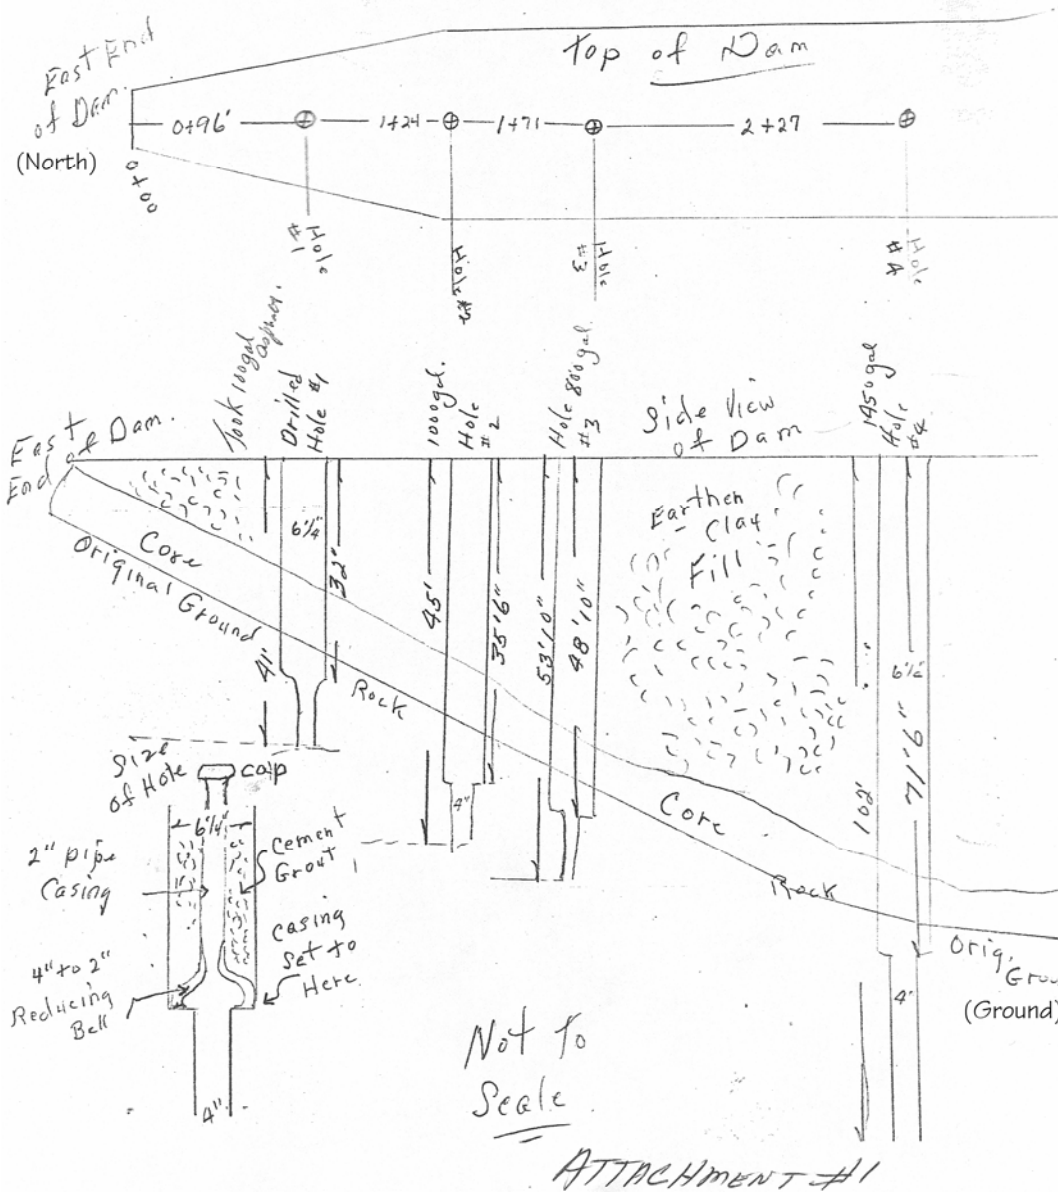
Figure 1. 1965 Dam drilling

1965, Jun 8, from a letter by Harold Herd (Lake Development Enterprises) to Don Parrot (Lake Tishomingo) regarding the owners’ concern of the dam’s “leak problem.” Included in this letter is a rough drawing of the Development’s work which had blocked off some of the seepage and apparently did not slow down one spot where the largest concentration of water was coming out. (see Figures 1 and 2.)

Four holes were drilled from the top of the dam through the core rock and beyond. Each hole was 6.25 inches wide lined with a casing. Inside this casing was 2 inches of cement grout surrounding a 2 inch pipe. The 2 inch pipe was fitted to a reducing bell which allowed the pipe size to increase to 4 inches without any surrounding casings. The four sites were drilled to a depth of 41 feet, 45 feet, 53 5/6 feet and 102 feet which was through the rock base. Into these pipes 100, 1000, 800 and 1450 gallons, respectively, of pure asphalt was pumped. Each drill site pipe was capped.

Another drilling was to be done close to the #4 location (the largest concentration of water area) to attempt to seal that area in the same manner.
