August 22 Dam Leak Committee Meeting Summary

Appendix A. Preliminary History Report by Clarue Holland, Lake Tishomingo Dam Committee, 17 August 2006

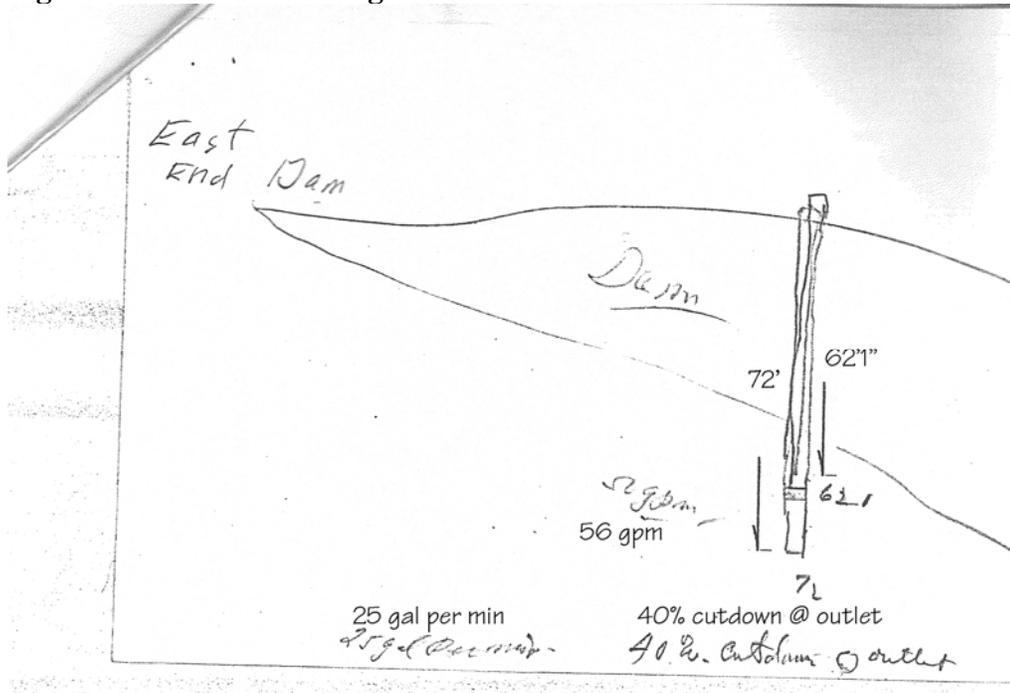
Figure 2. 1965 Dam drilling

1965, Jun 8, from a letter by Harold Herd (Lake Development Enterprises) to Don Parrot (Lake Tishomingo) regarding the owners’ concern of the dam’s “leak problem.” Included in this letter is a rough drawing of the Development’s work which had blocked off some of the seepage and apparently did not slow down one spot where the largest concentration of water was coming out. (see Figures 1 and 2.)

Four holes were drilled from the top of the dam through the core rock and beyond. Each hole was 6.25 inches wide lined with a casing. Inside this casing was 2 inches of cement grout surrounding a 2 inch pipe. The 2 inch pipe was fitted to a reducing bell which allowed the pipe size to increase to 4 inches without any surrounding casings. The four sites were drilled to a depth of 41 feet, 45 feet, 53 5/6 feet and 102 feet which was through the rock base. Into these pipes 100, 1000, 800 and 1450 gallons, respectively, of pure asphalt was pumped. Each drill site pipe was capped.

Another drilling was to be done close to the #4 location (the largest concentration of water area) to attempt to seal that area in the same manner.
