PUBLIC WATER SUPPLY DISTRICT #13
Minutes of the April 9, 2014
Regular Session of the Board of Trustees

The Board of Directors of Public Water District #13, Jefferson County Missouri met in regular session at 7:00 p.m. on April 9, 2014 at 5706 N. Lakeshore Dr., Hillsboro, Missouri.

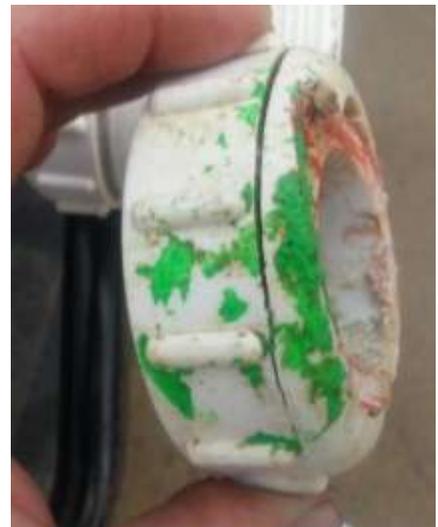
On Apr 5 at 1118 homeowner calls Dave A. to tell him there is water running out of green lid at street. At 1345 Dave inspects leak which is at the main connection at the road. Dave shuts off power at home control panel which stops the leak temporarily. Dave schedules repairs for next Monday.

On Apr 6 at 1009 JJ receives wakeup call from homeowner that leak is still flowing. At 1100 JJ & RH visit site. Leak at riser flowing strongly. Shutting off SOV at street stops leak, so leak is between street SOV and house.

On Apr 9 at 1000: Pete and crew are onsite. SOV, CV and PE pipe exposed. At 1400 Pete said it was a split nut on the CV (shown at right). A previous leak was also caused by a broken CV. This seems to be a weak point.
