# Lake Monitoring 2025

Prepared for Lake Tishomingo by Gateway Lake Management LLC

Visit Date: Wednesday 4/2/2025

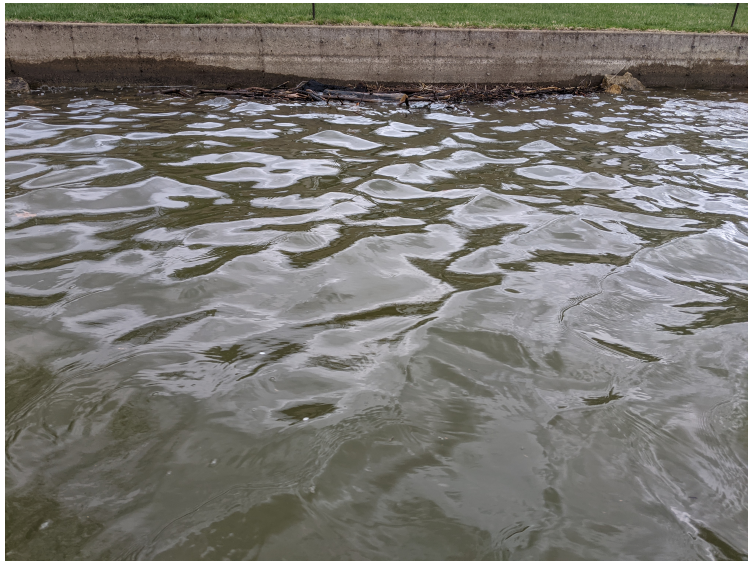
Picture 1

The recent rains and windy weather conditions have contributed to higher dissolved oxygen levels of 7.9mg/l. These rains have also brought in noticeable debris that is washed up on most of the shorelines (as seen in picture 1). Boaters should use caution as some larger logs were seen floating around the middle of the lake (as seen in picture 2). The debris is likely to continue or increase as more heavy rains are expected for the upcoming weekend.
