# Lake Monitoring 2025

Prepared for Lake Tishomingo by Gateway Lake Management LLC

Visit Date: Monday 5/5/2025

## Visit 3 Observations

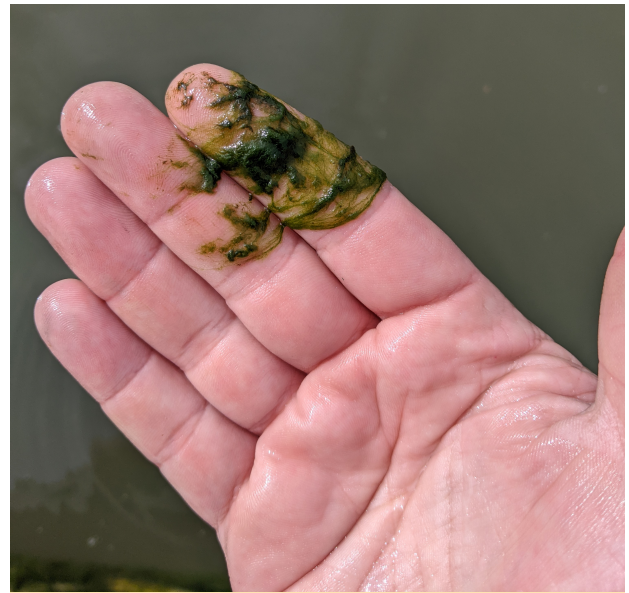
Picture 1

Lake vegetation is still minimal with the throw rake coming up clean and no submersed vegetation present. Filamentous algae is very hard to find but can be seen on some rip rap and shallow docks on the south end of the lake (as seen in picture 1).

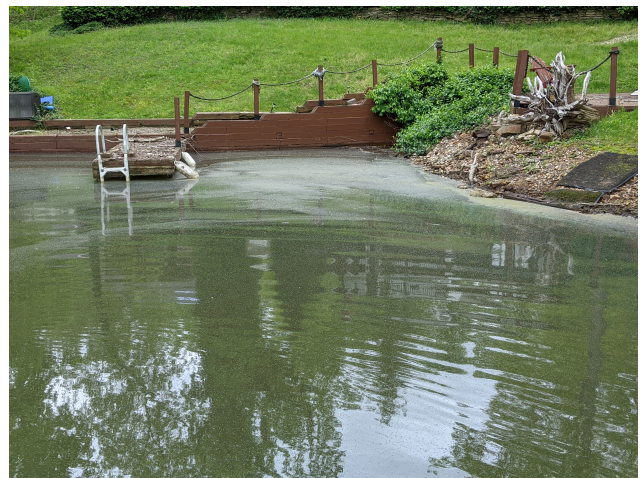
Picture 2

The excess debris from trees and runoff has been degrading which caused the dissolved oxygen levels to drop a bit to 6.9 mg/l. Overall the health and visuals of the lake is excellent and should keep improving as we head into mid May. Tree pollen is now the only slight inconvenience and can be seen on the surface in the backs of coves (as seen in picture 2). A promising start to summer as we approach swimming and boating season.
