Lake Monitoring 2025

Prepared for Lake Tishomingo by Gateway Lake Management LLC

Visit Date: Tuesday 6/3/2025

Visit 5 Observations

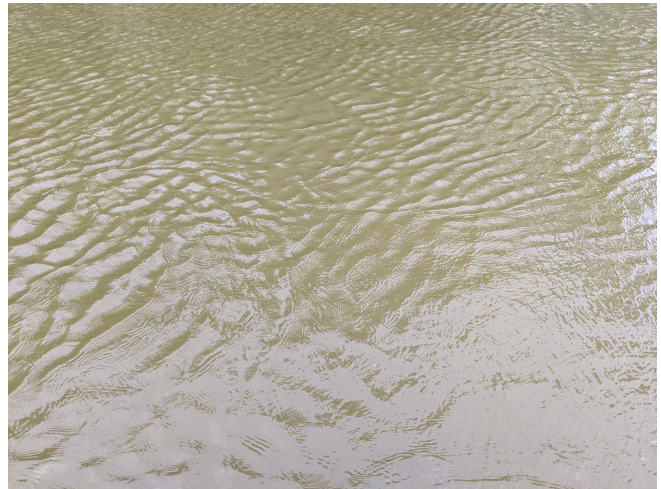
Picture 1

Water levels have dropped since last visit and the debris is much less than before. Suspended sediment is still hanging around giving the lake lower visibility at about 2-3 feet. Aesthetically the lake looks muddy due to these conditions (as seen in Picture 1) but the overall health of the lake is good. Dissolved oxygen is high at 8.5 mg/l and pH is at 8.4 showing most parameters are in an ideal state.

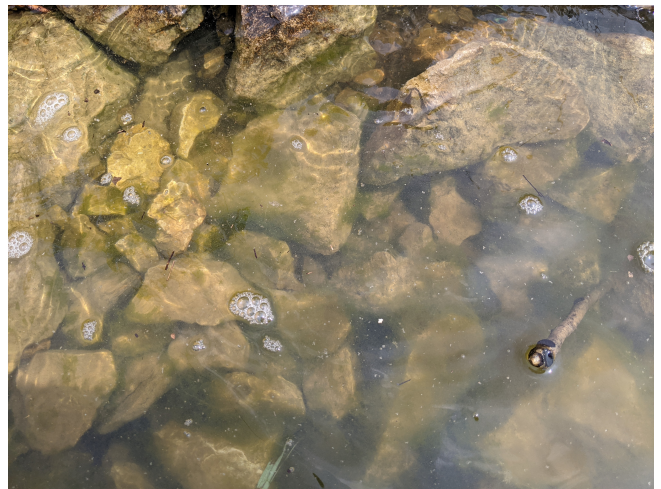
Picture 2

Submersed weeds are still nowhere to be seen. The cooler water temperatures are helping keep the planktonic bloom away which normally would be coming on strong in June. The only detectable nuisance vegetation is a small amount of filamentous algae growing in some shallow rip rap areas (as seen in Picture 2).
