# Lake Monitoring 2024

Prepared for Lake Tishomingo by Gateway Lake Management LLC  
Visit Date: Monday 6/24/2024

## Visit 6 Observations

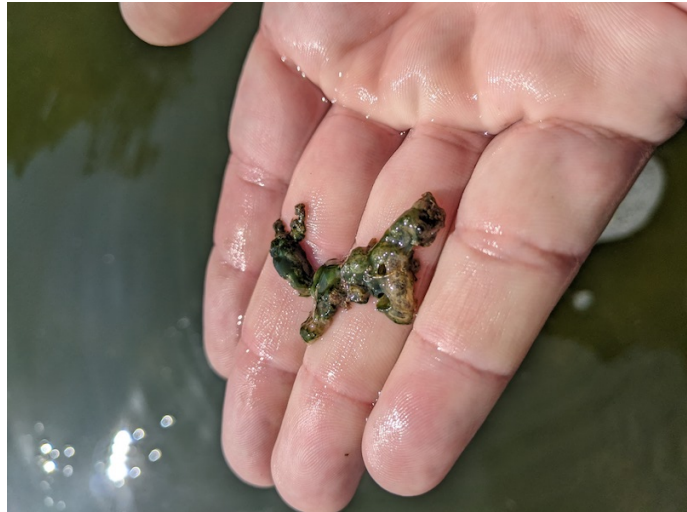
Picture 1

The throw rake continues to come up empty all over showing no signs of submersed weed growth. What has appeared on this visit is a very minor amount of oscillatoria algae (as seen in Picture 1). It should be noted that this is a type of cyanobacterium and I will continue to look for any increase in density and report back. The planktonic bloom is in the same cyanobacterium category and any increase in density will be noted.

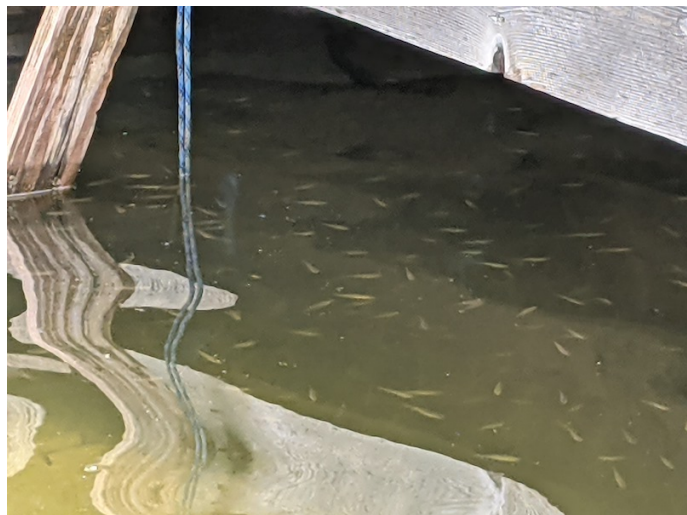
Picture 2

Fish are very active right now and most have moved off the spawning beds. With high oxygen readings at 7.2mg/l they should be actively feeding around structure. Docks are providing great cover for bait fish and many were seen covered with small minnows (as seen in Picture 2).
