Lake Monitoring 2024

Prepared for Lake Tishomingo by Gateway Lake Management LLC

Visit Date: Monday 7/8/2024

Visit 7 Observations

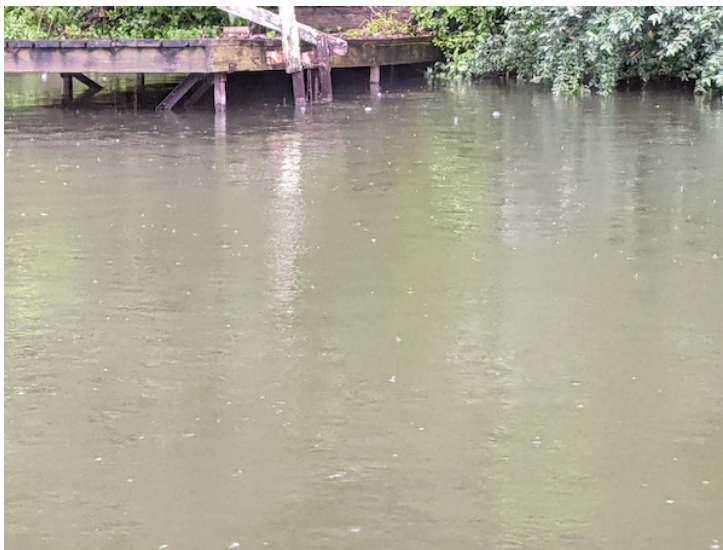
Picture 1

The biggest change this visit is water visibility, the rain has made the water murky. Water levels have risen right up to the shoreline with some docks near the water line (as seen in Picture 1). Take caution while boating as many new logs have washed in from the creek that feeds the lake. Smaller pieces of debris can be seen all over the lake but and is causing problems where it builds up (as seen in Picture 2).
