Lake Monitoring 2024

Prepared for Lake Tishomingo by Gateway Lake Management LLC

Visit Date: Tuesday 8/6/2024

Visit 9 Observations

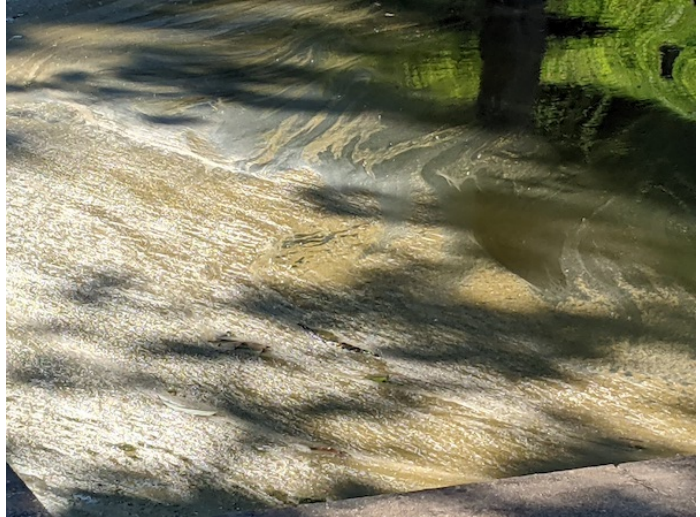
Picture 1

This week's visit shows little change since the last. High heat and sporadic showers have taken over since heavy rain pushed in nutrients in July. The lake has a noticeable planktonic algae bloom that has spread to about 60% coverage (as seen in Picture 1). Visibility is at about 3-4 feet and oxygen levels remain high at 8.6 mg/l. The planktonic bloom can be unsightly, but it shows the lake is highly productive and beneficial for growing fish.

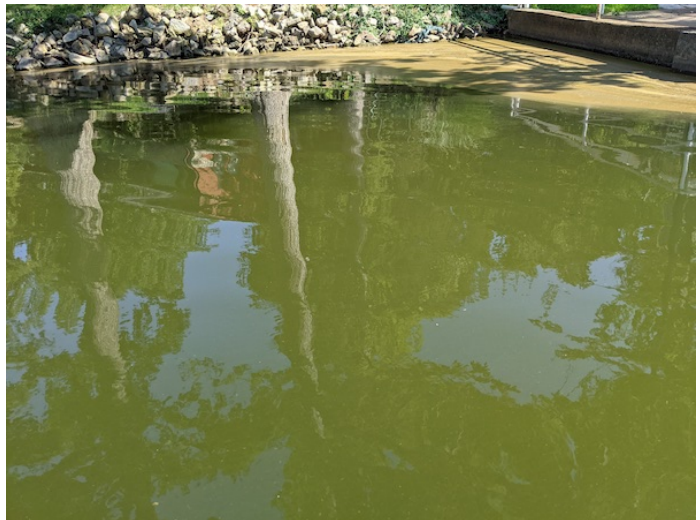
Picture 2

The weed rake is still coming up completely empty. Although some areas have a bloom occurring, overall conditions are decent. Backs of wind-blown covers show the worst vegetation coverage (as seen in Picture 2). Cooler temperatures and rain are expected and that should help decrease this bloom significantly.

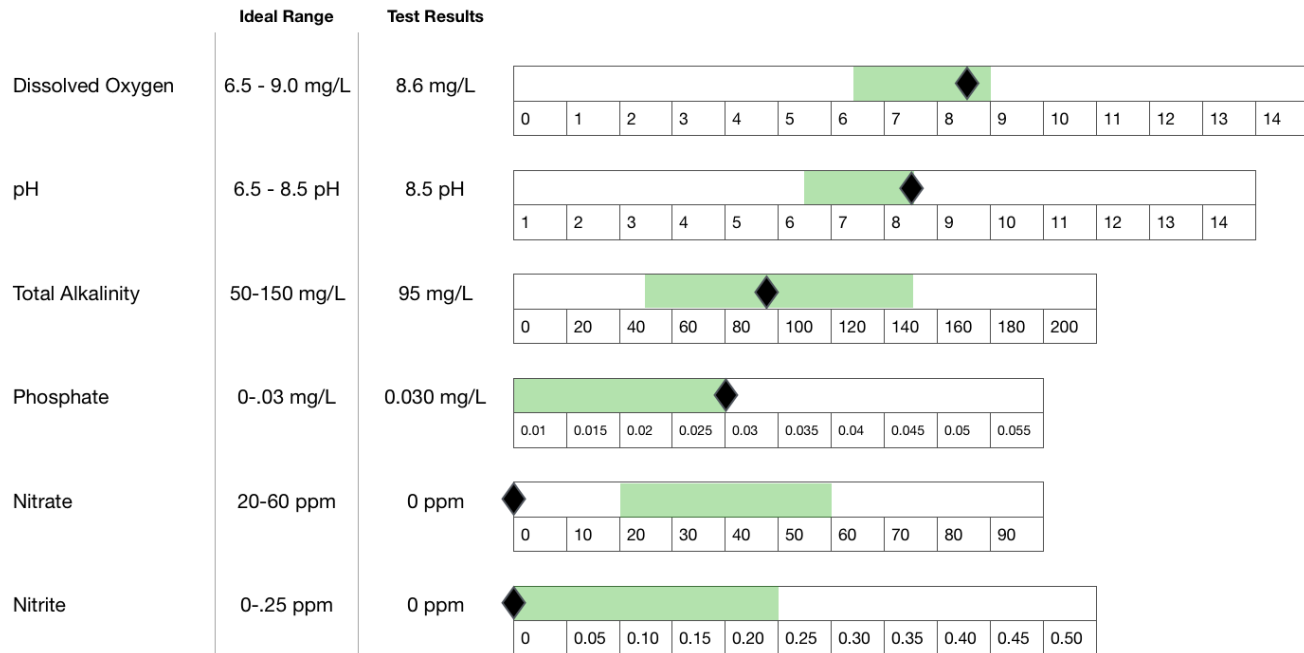
Figure 1

The water test was collected near the center of the lake.

Sample Collected: 8/6/2024 @ 10:33 AM

Weather Conditions: Sunny 82°F
