# Lake Monitoring 2024

Prepared for Lake Tishomingo by Gateway Lake Management LLC  
Visit Date: Wednesday 9/4/2024

## Visit 11 Observations

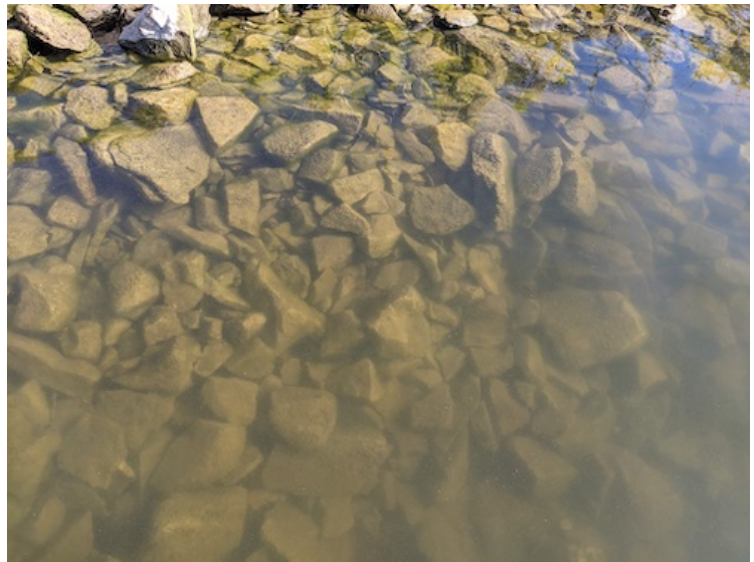
Picture 1

This week is bringing much cooler temperatures as we begin the fall season. Water temperatures are dropping and that will cause vegetation such as the slight planktonic bloom present to naturally die off. The water visibility is down to 2-3 feet, and this is most likely from the breakdown of detritus and existing vegetation. During the last visit filamentous algae was observed growing on rocks near the dam which has since died off (as seen in Picture 1).

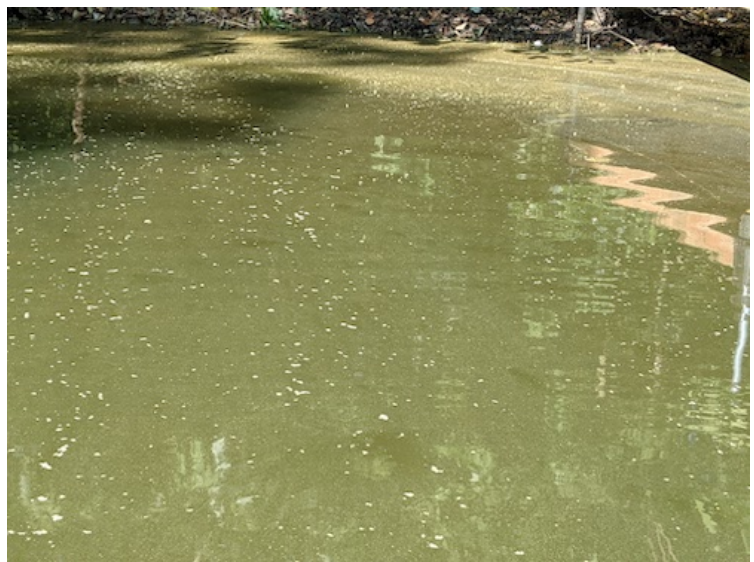
Picture 2

Overall the lake is in great shape with no submersed weeds present and dissolved oxygen still good for this time of the year at 7.8 mg/l. Some pollen is present on the surface and can be easily seen in the wind-blown coves (as seen in Picture 2). This should diminish with a good rainfall as it degrades.
