June 7, 2019

6/5/2019 Red Oak grass cutters reported a bulge on the back of the dam. They said there is an area that is steeper than it used to be.

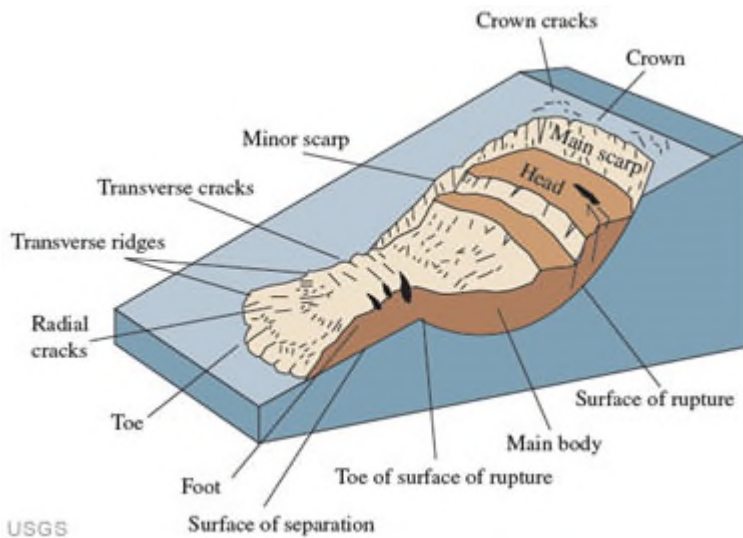
- This is an extremely large area for a bulge.
BULGE IS PROBABLY NOT A TERM A DAM ENGINEER WOULD USE. I BELIEVE JEFF WAS AFRAID THAT THE DAM WAS IN THE PROCESS OF EXPERIENCING A LANDSLIDE. RAIN WOULD CONTRIBUTE TO THE LIKELYHOOD OF A SLIDE AS WET SOIL IS HEAVIER AND MORE LIKELY TO MOVE. HERE'S AN ILLUSTRATION FROM GEOLOGY.COM/USGS/LANDSLIDES/

JEFF SAID HE WOULD EXPECT THE SLIDE AREA TO BE STEEPER AT THE TOP AND HAVE MORE MATERIAL AT THE BOTTOM. ALTHOUGH THERE WERE SOME SMALL AREAS OF THE DAM THAT HAD THIS CHARACTERISTIC, IT WAS NOT OBVIOUS ENOUGH TO INDICATE A SLIDE. NOR WAS THERE EVIDENCE THAT A CHANGE HAD OCCURRED RECENTLY. JEFF ASKED IF THERE WAS A RECENT SURVEY OF THE BACK OF THE DAM AS A FRAME OF REFERENCE. JANET HAS SENT JEFF A TOPO SURVEY FROM 2008.
